**Federal Building and Fire Safety Investigation of the
World Trade Center Disaster**

**Mechanical and Metallurgical
Analysis of Structural Steel**

September 2005

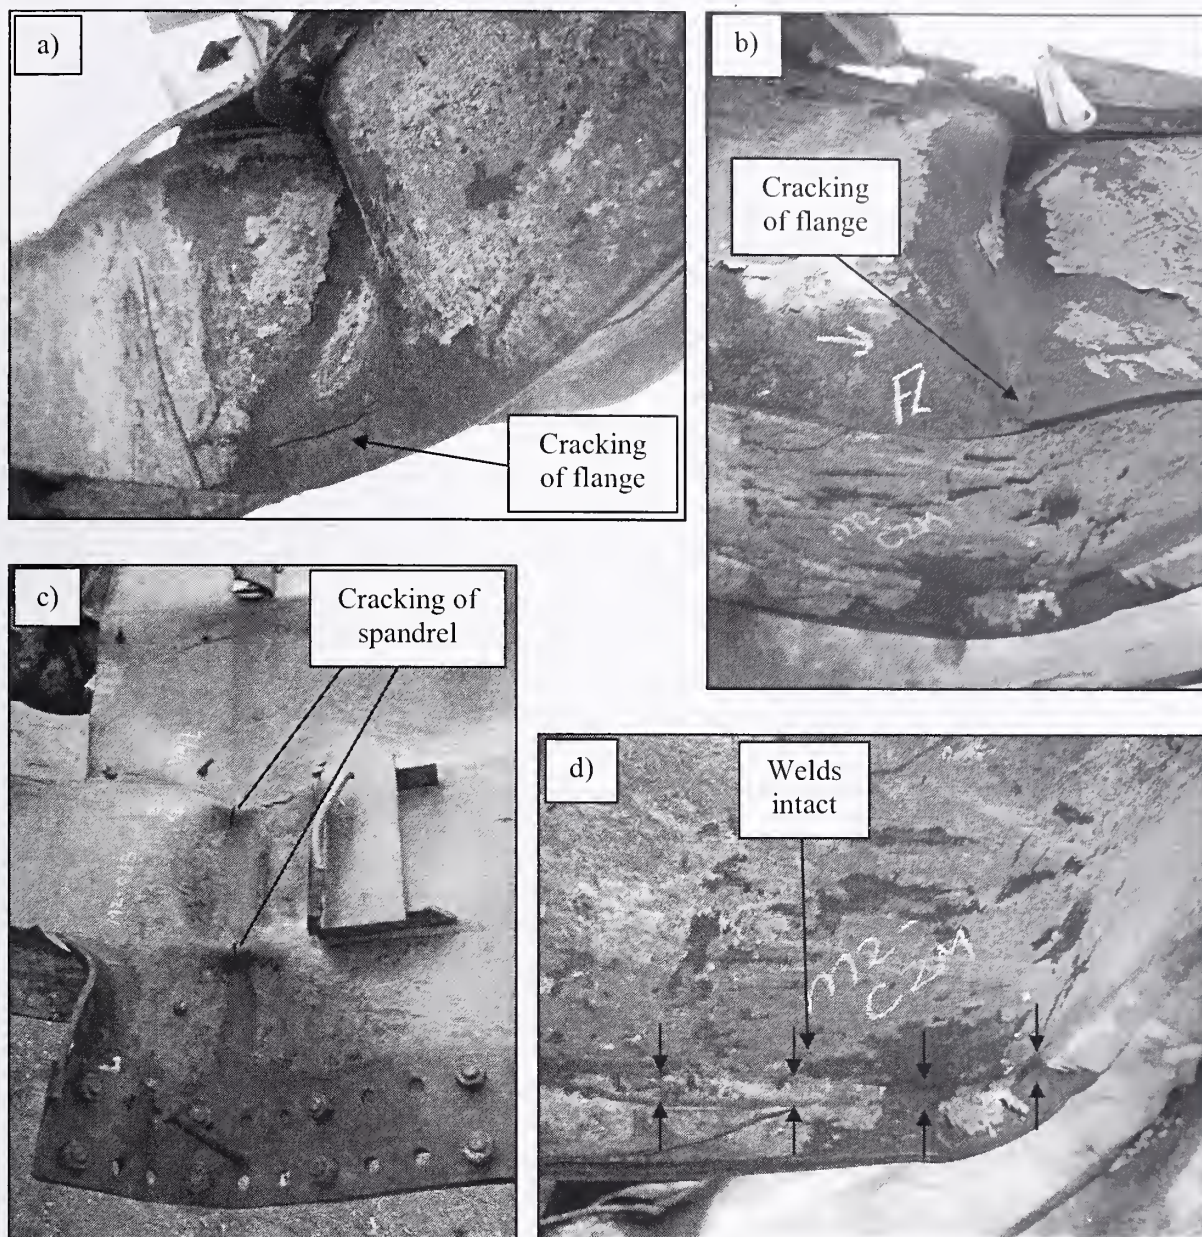
Damage to the lower portion of panel M-2 (WTC 1, column line 130, floors 96 to 99) was clearly associated with impact, which led to the missing endplates for columns 129 and 130. The inner and outer web plates of both columns have thinned in this area due to plastic deformation, Fig. 6-23a. The fracturing of the plates propagated as a 45 degree slant crack, oscillating between positive and negative 45 degrees with respect to the normal of the plate. The necking (thinning) of the outer web plate, plotted in Fig. 6-23b, indicates significant ductility, even at the high-strain rates associated with impact. Large buckles were observed on both flanges for columns 129 and 130 with some splitting occurring in the base material of the flanges (Figs. 6-24a and 6-24b) and spandrels (Fig. 6-24c). However, the welds found near this bending point remained intact (Fig. 6-24d).

Figure 6–24. Damage images from sample M-2 (A130: 96-99). a) Large buckles observed on the flange plates of column 130, b) cracking of the flange plates on column 130, c) cracking of spandrel at 97th floor level, and d) no cracking of the welds in this area on column 130.

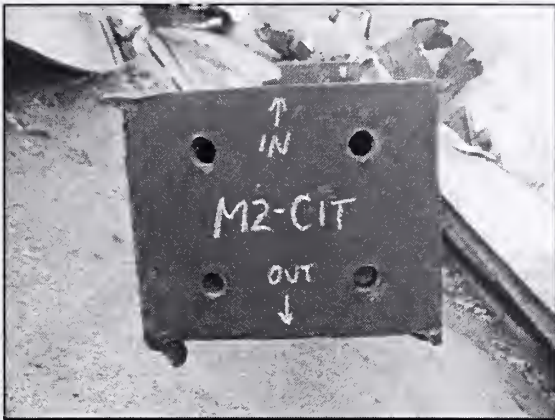
Failure mode: Type 1b, bolt hole tear out

Figure 6–25. Photographs of recovered spandrel connections from sample M-2 (A130: 96-99) (continued).

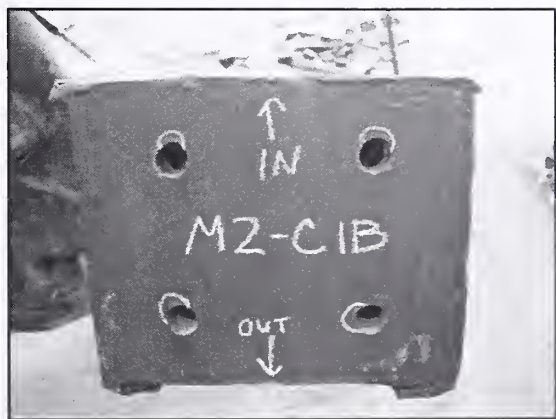
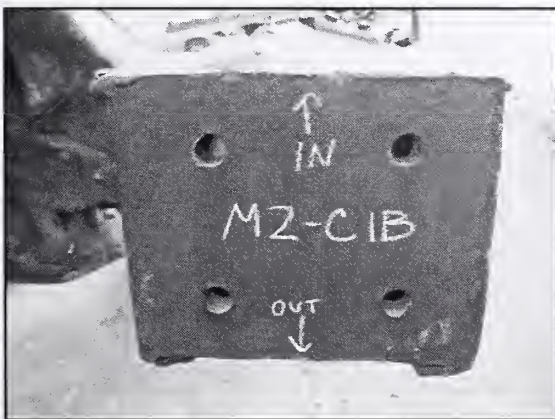
M2-C1T

Figure 6–26. Photographs of recovered end plate connections from sample M-2 (A127: 97-100). Both ends of column 131 had bolt failure that resulted in deformation of the bolt holes in the end plates.

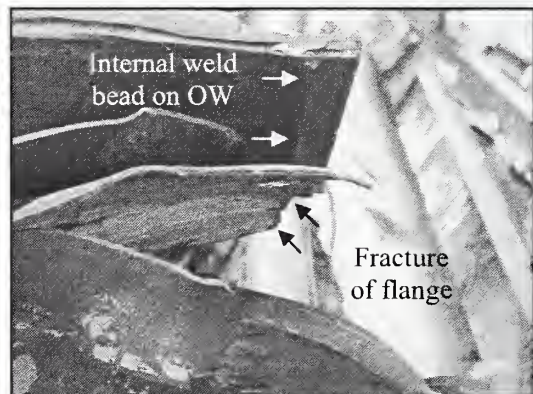
M2-C2T
WTC1
Col 130
F1 99

The state of the recovered bottom portion of columns 129 and 130 was nearly identical to the condition after the impact for panel M-2 (A130: 96-99). Both end plates were ripped completely out of the column, Fig. 6-26. Failure was a mixture of fracture in the base plates (portion of the flange/web still attached to the end plate) and clean separation of the end plate from the flange/web (complete flange/web recovered with internal weld bead visible). Bolt hole deformation for column 131 indicated that the connection was broken by bending inward of the lower column of the connection. Finally, while bolt failure was observed at the 99th floor splice of column 129, it can be noted that some separation existed between the flange plates of the column and the endplate.

No change in bolt
hole shape

Figure 6–26. Photographs of recovered end plate connections from sample M-2 (A127: 97-100). The upper end plate experienced bolt hole failure. The bottom end plate of column 130 was ripped out upon impact of the airplane. Failure was found to be a mixture of fracture in the base plates (portion of the flange/web still attached to the end plate) and clean separation of the end plate from the flange/web (complete flange/web recovered with internal weld bead visible) (continued).

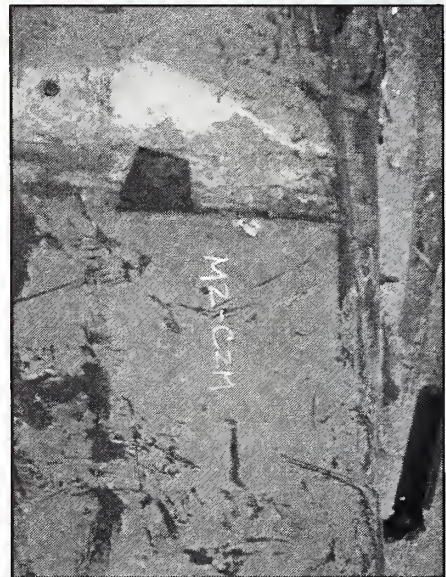
Tab plate ripped off at weld.

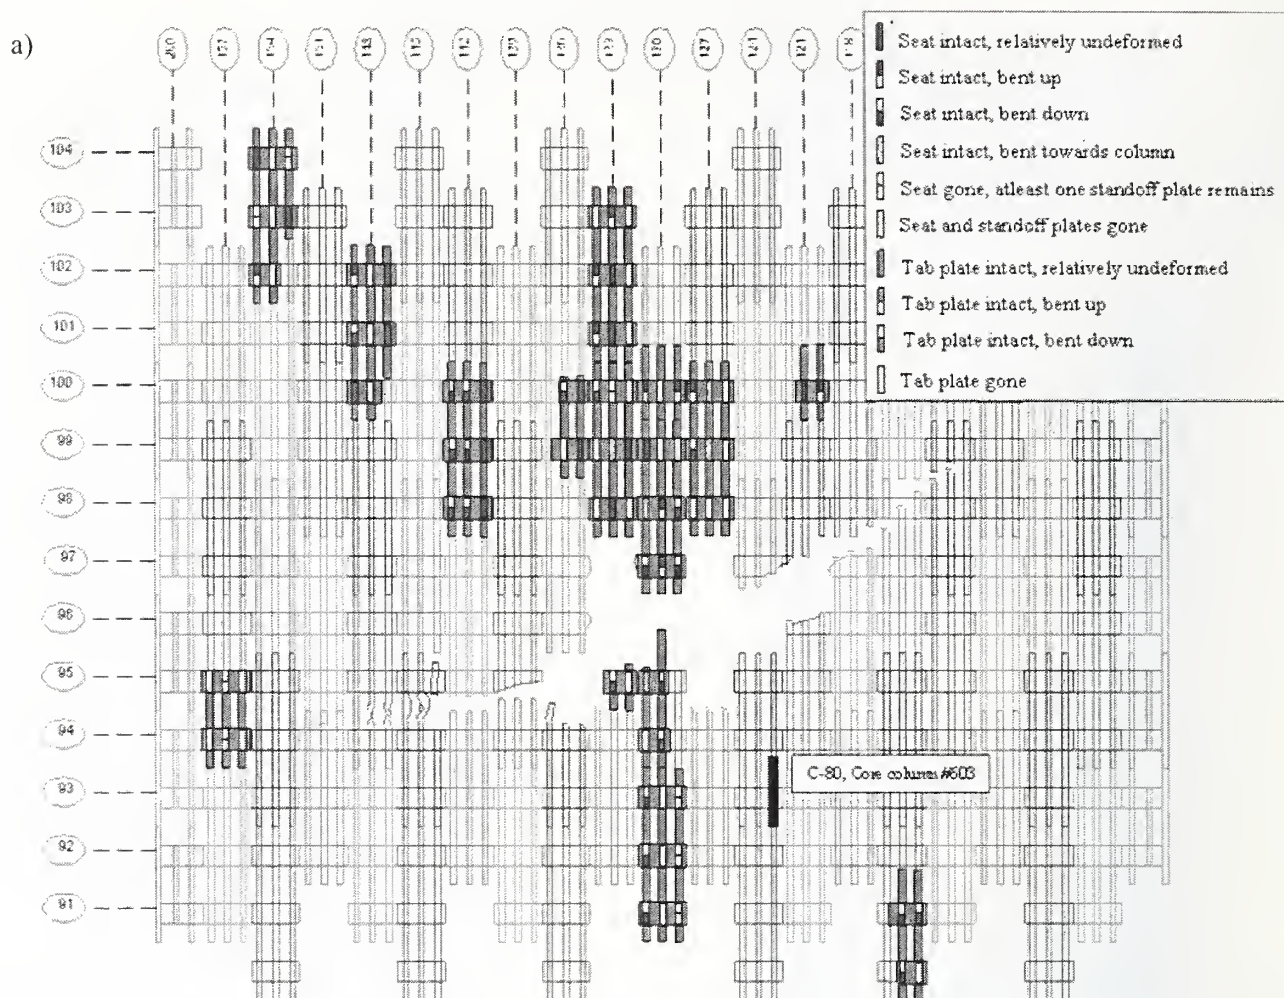
The most significant observations were made when the panels were categorized by their as-built elevation within the building, Fig. 6–28. Of the 28 floor truss connectors at or below the impact floors for WTC 1, 93 percent were either missing or bent downwards. Only 37 percent of the 38 floor truss connectors above the impact floors had similar characteristics. Comparable results were found for WTC 2 where 88 percent of the floor truss connectors below the impact floors were bent down or missing, while only 55 percent of the floor truss connectors above this region had such damage characteristics. This occurrence was most likely a result of the overloading of the lower floors (“pancaking” mechanism) during collapse of the building.

Figure 6-28a. Damage diagram overlaid with recovered samples and damage of connectors.

Figure 6–28b. Damage of connectors. At or below the 95th floor, all connectors are either bent down or missing.

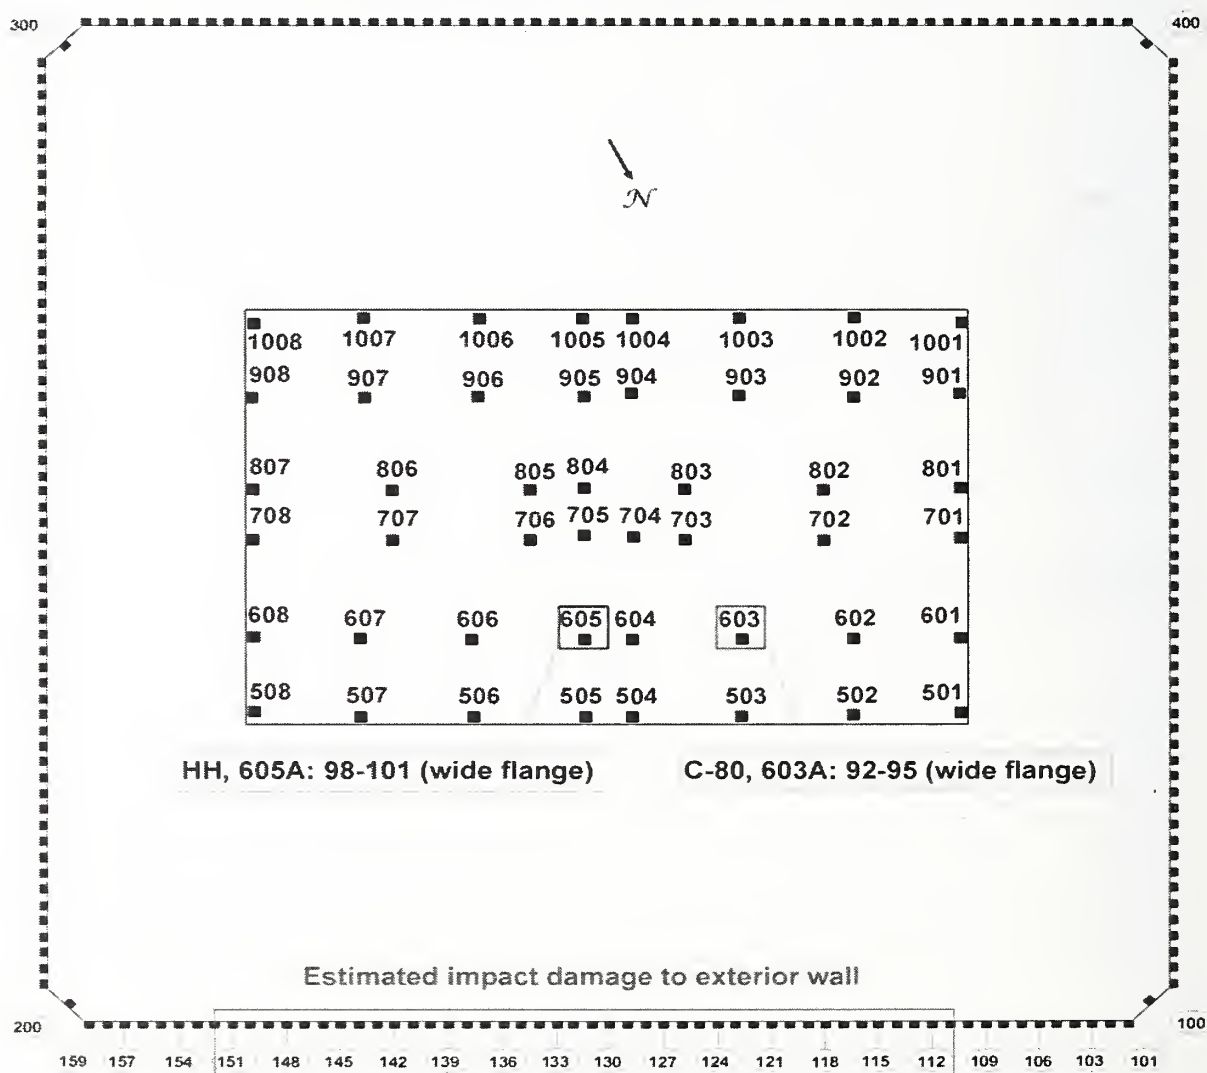
Figure 6–29a. Positioning of the recovered core columns with the core area for WTC 1.

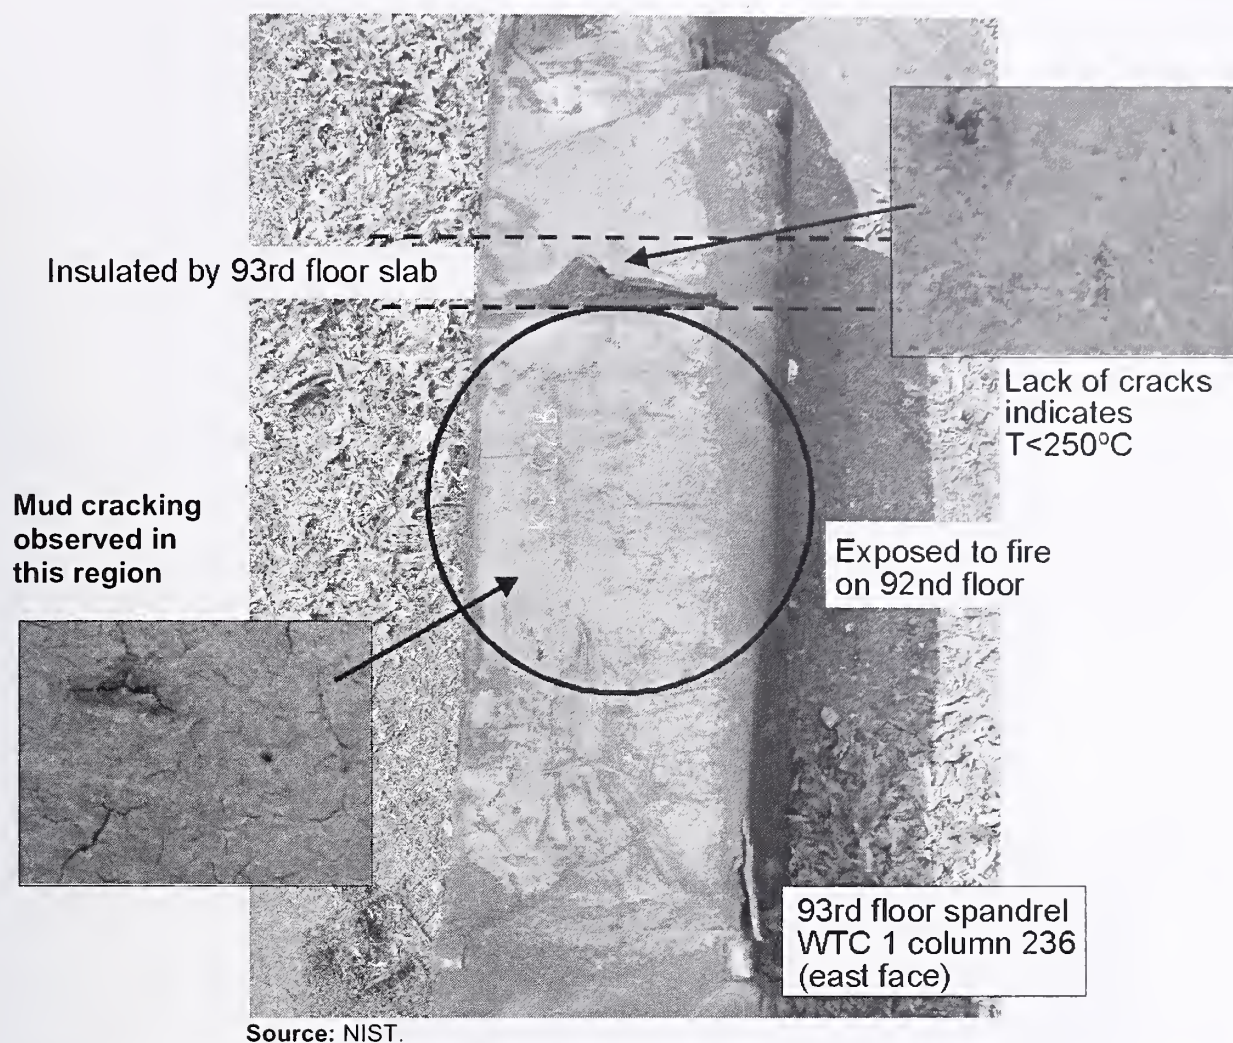
Figure 6–37. Spandrel at the 93rd floor of column 236 from sample K-2 (A236: 92-95). Paint mud cracking was found below the 93rd floor line, no evidence of paint mud cracking was found above floor line.

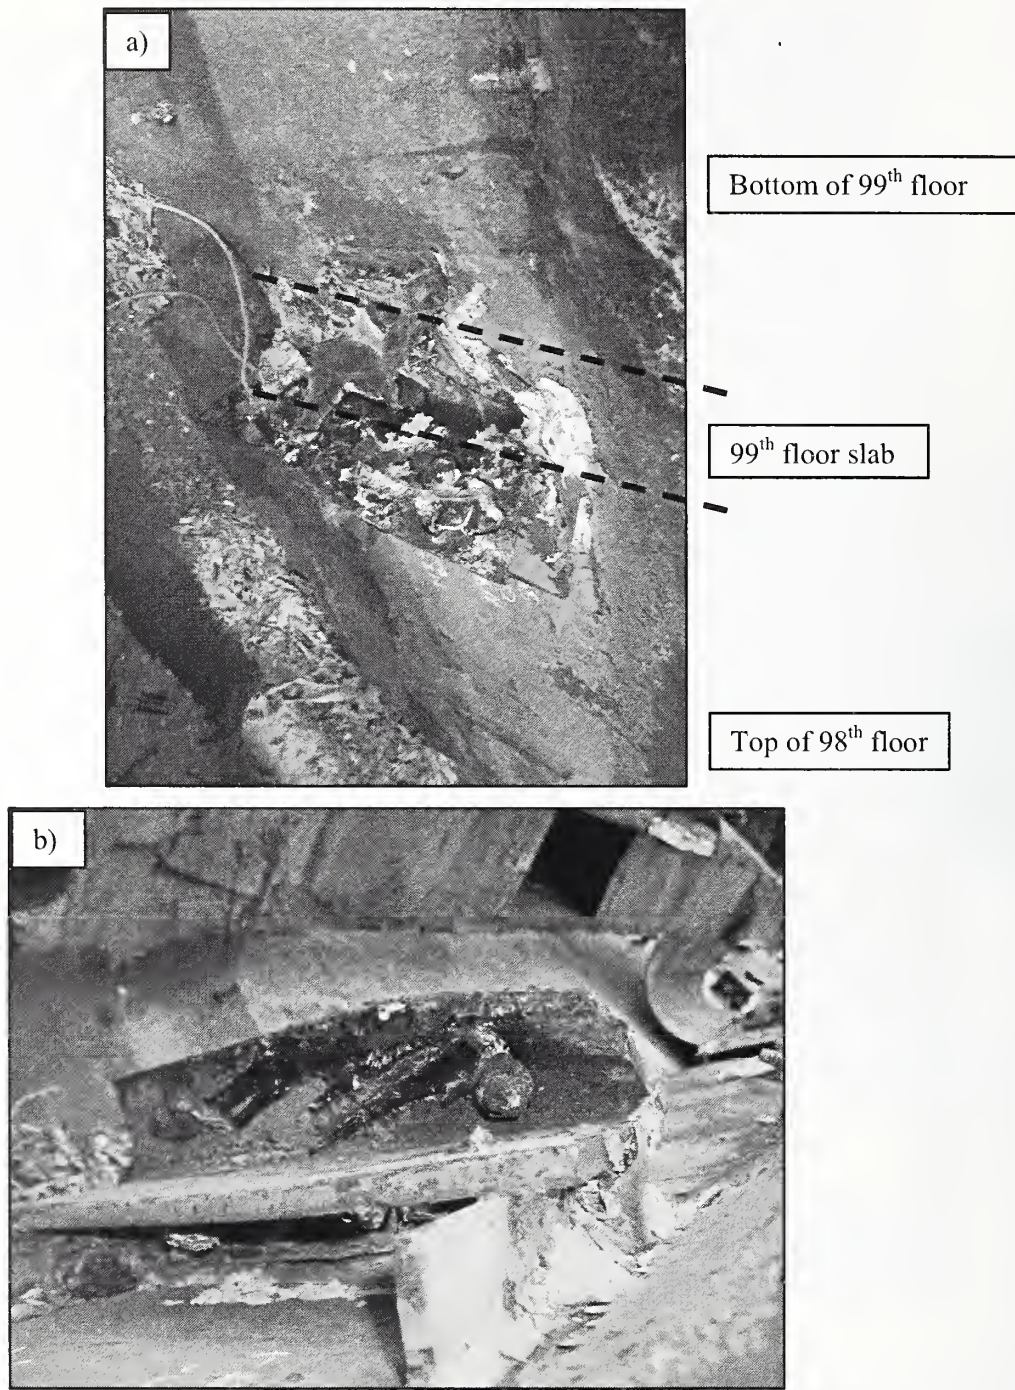
Figure 6–38. Truss seat of the 99th floor on column 143 of sample N-8 (A142: 97-100).
a) Top view showing the re-solidified black plastic with embedded papers, most likely a binder of some type and b) bottom view showing the drip pattern. It was unknown when the high-temperature excursion may have occurred.

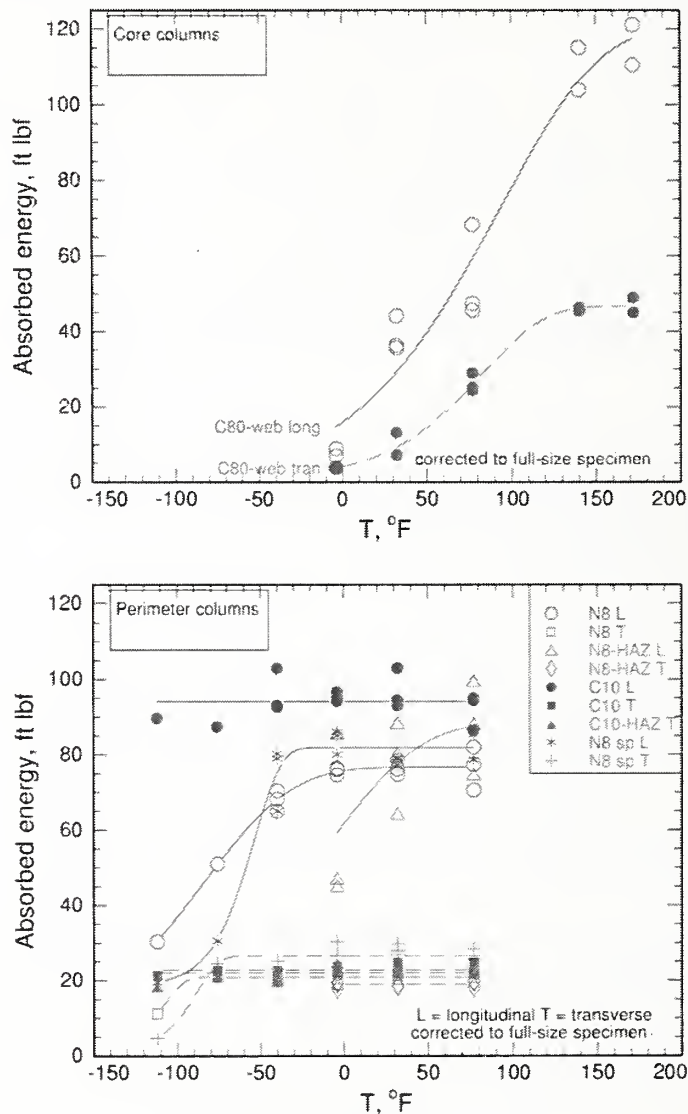
Figure 7–7 summarizes the results of Charpy tests on perimeter and core column steels. All the perimeter column steels have large upper shelf energies and transition temperatures well below 0 °F. The transition temperatures of the web of the wide-flange specimen, Fig. 7–7, and the truss rods and angles, not shown, are near room temperature, but they still possess adequate toughness for use as structural steels. The transition temperatures of the truss seat steels are above room temperature, and the absorbed energy of the steels even at room temperature is low, indicating a propensity for low-energy failure.

Figure 7–7. Summary data for Charpy tests. Lower figure: perimeter column steels; upper figure: core column steels.

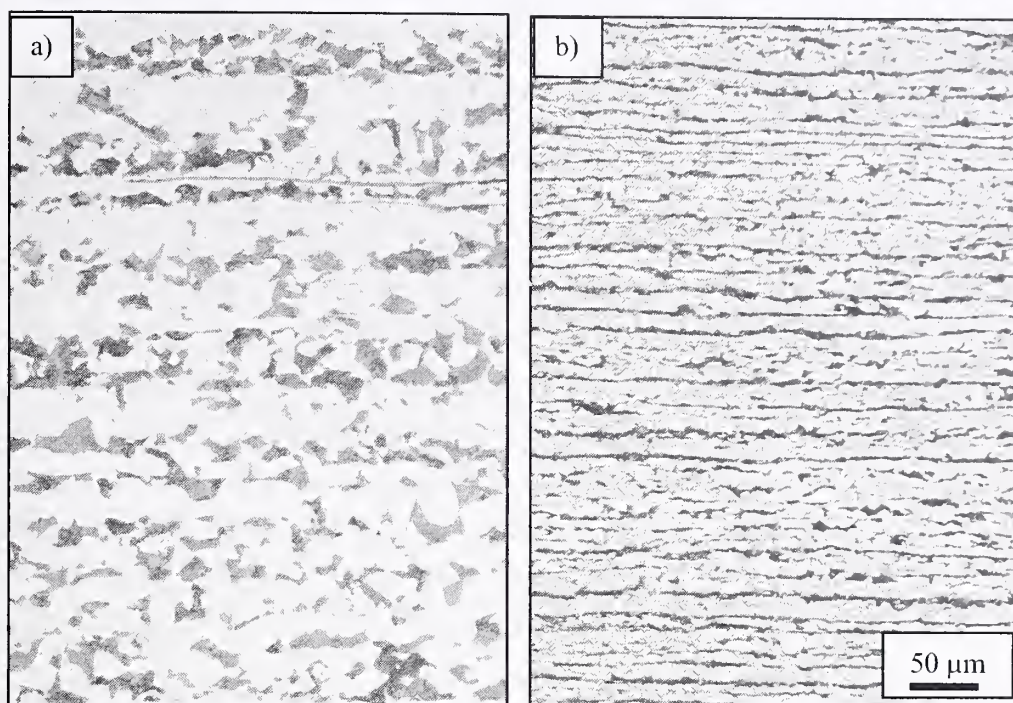
For the exterior panel sections, two different microstructural types were observed. Flange, web, and spandrel plates with specified minimum yield strengths less than 70 ksi were ferrite-pearlite (Fig. 8-1). Additionally, inner webs with F_y of 70 ksi and 75 ksi were ferrite-pearlite. For the Yawata produced plates (flange, outer web, and spandrel), this type of microstructure was expected given the measured plate thickness and specified minimum yield strength (refer to NIST NCSTAR 1-3A). Plates with F_y less than 70 ksi were typically hot rolled unless the following sizes were exceeded for a given F_y : 0.5" for 65 ksi, 1.25" for 60 ksi, and 1.5" for 55 ksi. For these specified plates, as well as those with minimum yield strengths equal to or greater than 70 ksi, "quenched-and-tempered" microstructures were observed (Fig. 8-2).

Figure 8-1. Microstructure of ferritic-pearlitic WTC perimeter column flange plate steels.
a) $F_y = 45$ ksi (unidentified perimeter column with "45" flange stamping) and b) $F_y = 60$ ksi (WTC 1, column 126, 97th floor).

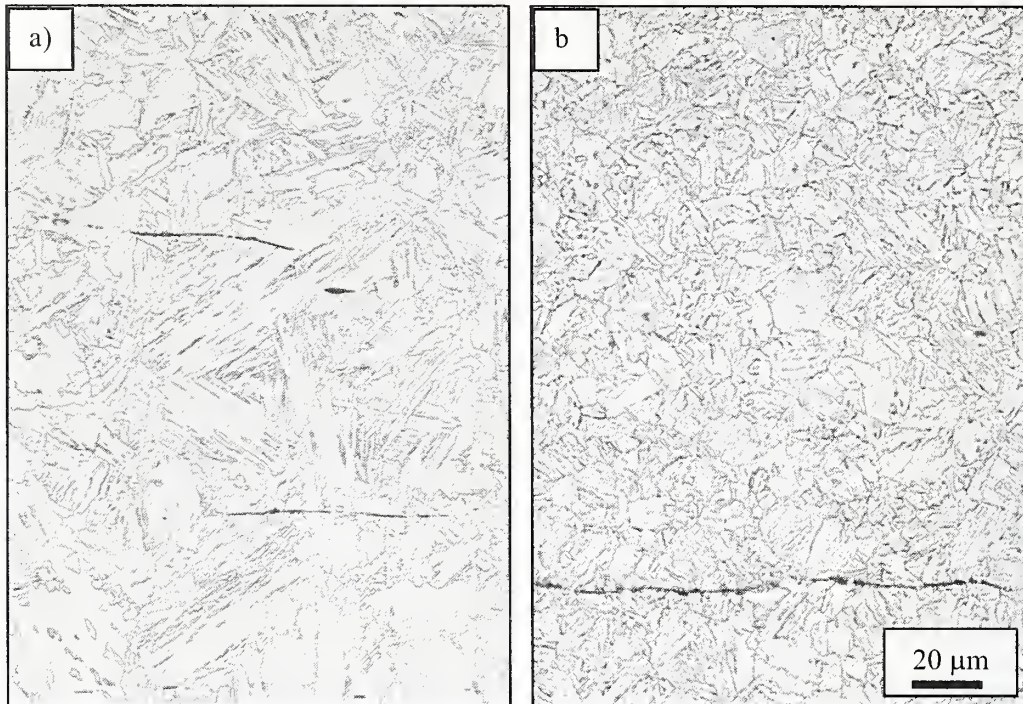
Microstructure varied within each of the two structure types, depending on product type, gauge, and strength level. Ferrite-pearlite steels had variations in ferrite grain size, ferrite grain shape, pearlite lamellar spacing, and banding of microstructural constituents with a change in specified F_y and gauge of the plate. Examples of these microstructures are shown in Fig. 8-1. Similarly, the quenched and tempered steels had variations with F_y . Plates with $F_y = 70$ ksi had a coarse Widmanstätten morphology of ferrite with coarse cementite precipitates while the higher strength plates had what appeared to be a tempered martensitic structure, as shown in Fig. 8-2.

Figure 8–2. Examples of “quenched and tempered” WTC perimeter column flange steel.
a) $F_y = 70$ ksi (WTC 1, column 224, 94th floor) and b) $F_y = 80$ ksi (WTC 1, column 207, 89th floor).

For each of the designated minimum yield strengths, the type of structures observed was expected for steels of that era. While the microstructural features may have varied from plate to plate, there was no indication that the practices followed to produce the plates were improper.
